INFORMATION FROM THE INVESTIGATING OFFICERS REPORT OF MOTOR VEHICLE ACCIDENT

Case Number:	17-004241	Report to All Drivers:	YES	At Intersection with:	"N/A"
Date of Acc:	06/30/17	Legal Intervention:	NO	Div HWay Trvl Dir:	"N/A"
Time of Acc:	09:25 Hrs.	Private Property:	NO	Distance 1:	"N/A"
Name of Agency:	O'BRIEN COUNTY SHERIFF'S OFF	County:	O'BRIEN - 71	Direction 1:	"N/A"
Officer:	VANDERVEEN STEVEN	Acc Loc City:		Distance 2:	"N/A"
Badge #:	71-9	Acc Dir From City:	"N/A"	Direction 2:	"N/A"
Report Date:	06/30/2017	Closest City:	"N/A"	X-Coordinate:	00278543
Officer Notified:	09:31 Hrs.	Miles From City:	"N/A"	Y-Coordinate:	04785087
Officer Arrived:	09:45 Hrs.	Road,Street,HWay:	"N/A"	Location Literal	US 18/320TH ST
Scene Investigated:	YES	Definable Location:	"N/A"	Description:	
		Milepost Number:	"N/A"

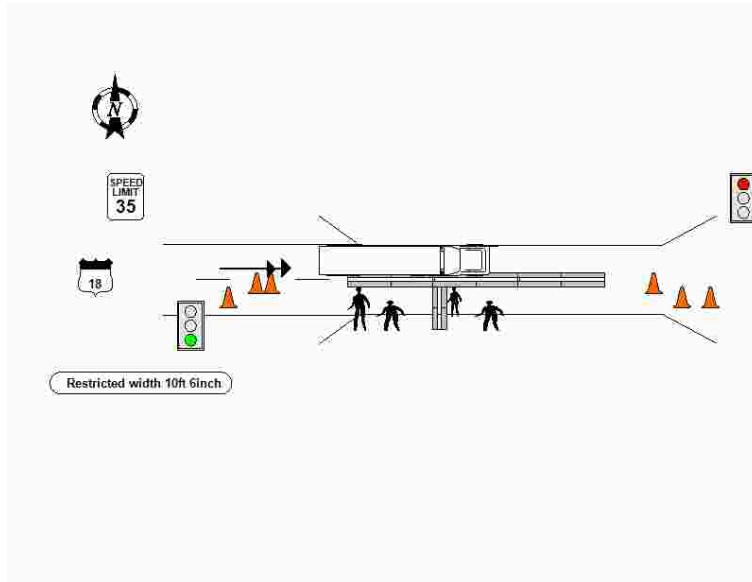
Diagram

Vehicle #1 was a semi pulling a flatbed loaded with round hay bales. Vehicle #1 was eastbound on Highway 18. At Oak Hill and Highway 18 there is an orange sign stating "Wide Loads over 10' 6" exit here". Then "Road work ahead 35mph" "Restricted width ahead 10' 6" then "One lane road ahead" then signs indicating a traffic signal ahead, then a temporary traffic signal and cones shifting traffic to the left lane to alternate on the north side of the bridge. Construction workers were preparing a concrete finisher on the south side of the bridge. Vehicle #1 had Wide load banners on his truck and red flags on the corners of his truck and load. The hay bales were loaded with slightly more overhang on the passengers side of the trailer than the drivers side. When vehicle #1 crossed the bridge the hay bales on the passengers side of the truck impacted the concrete finisher causing heavy damage to the finisher and little to no damage to the hay. The hay bales were measured at 11 feet wide on the front of the truck and 10 feet 8 inches at the rear.
