INFORMATION FROM THE INVESTIGATING OFFICERS REPORT OF MOTOR VEHICLE ACCIDENT

Case Number: 17-006692	Report to All Drivers: Yes	At Intersection with:
Date of Acc: 10/05/17	Legal Intervention: No	Div HWay Trvl Dir:
Time of Acc: 21:20 Hrs.	Private Property: No	Distance 1:
Name of Agency: O'Brien County Sheriff's Off	County: O'Brien - 71	Direction 1:
Officer: DEPUTY BRAD STEVENS	Acc Loc City:	Distance 2:
Badge #: 71-10	Acc Dir From City:	Direction 2:
Report Date: 10/05/2017	Closest City:	X-Coordinate: 00296203
Officer Notified: 21:26 Hrs.	Miles From City:	Y-Coordinate: 04778073
Officer Arrived: 21:36 Hrs.	Road, Street, HWay:	Location Literal: VAN BUREN AVE AND
Scene Investigated: Yes	Definable Location:	Description: B024/360TH ST
	Milepost Number:

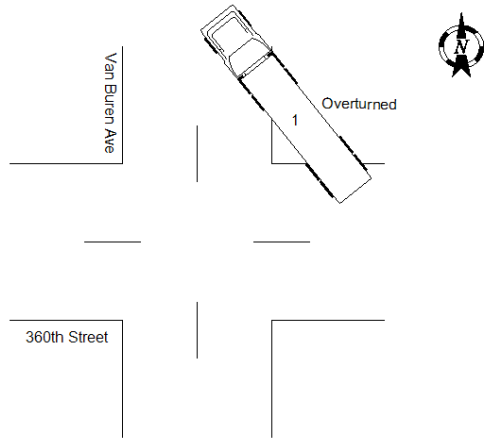
Diagram

Unit 1 was westbound on 360th Street. Unit 1 attempted to turn north onto Van Buren Avenue and turned too sharply causing both tractor and trailer to turn onto it's side coming to rest in the east ditch.
