INFORMATION FROM THE INVESTIGATING OFFICERS REPORT OF MOTOR VEHICLE ACCIDENT

Case Number: 17-007729	Report to All Drivers: Yes	At Intersection with:
Date of Acc: 11/22/17	Legal Intervention: No	Div HWay Trvl Dir:
Time of Acc: 23:18 Hrs.	Private Property: No	Distance 1:
Name of Agency: O'Brien County Sheriff's Off	County: O'Brien - 71	Direction 1:
Officer: VANDERVEEN STEVEN	Acc Loc City:	Distance 2:
Badge #: 71-9	Acc Dir From City:	Direction 2:
Report Date: 11/23/2017	Closest City:	X-Coordinate: 00278596
Officer Notified: 01:02 Hrs.	Miles From City:	Y-Coordinate: 04773779
Officer Arrived: 01:08 Hrs.	Road, Street, HWay:	Location Literal: B040/390TH ST
Scene Investigated: Yes	Definable Location:	Description:
	Milepost Number:

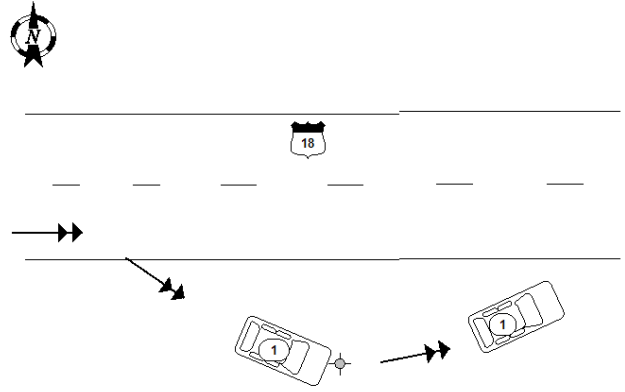
Diagram

VEHICLE #1 WAS EASTBOUND ON HIGHWAY 18. THE DRIVER STATED THAT HE WAS TIRED AND POSSIBLY FELL ASLEEP. THE VEHICLE WENT EAST PAST

THE SILVER AVENUE JUNCTION OF HIGHWAY 59 AND ENTERED THE SOUTH DITCH. THE CAR WENT UP AND EMBANKMENT AND STRUCK A UTILITY POLE BELONGING TO RURAL ELECTRIC.
