**INFORMATION FROM THE INVESTIGATING OFFICERS REPORT OF MOTOR VEHICLE ACCIDENT**

Case Number:	<b>17-007998</b>	Report to All Drivers:	<b>Yes</b>	At Intersection with:	
Date of Acc:	<b>12/07/17</b>	Legal Intervention:	<b>No</b>	Div HWay Trvl Dir:	
Time of Acc:	<b>05:01</b> Hrs.	Private Property:	<b>No</b>	Distance 1:	
Name of Agency:	<b>O'Brien County Sheriff's Off</b>	County:	<b>O'Brien - 71</b>	Direction 1:	
Officer:	<b>VANMEETEREN KEVEN</b>	Acc Loc City:		Distance 2:	
Badge #:	<b>71-7</b>	Acc Dir From City:		Direction 2:	
Report Date:	<b>12/07/2017</b>	Closest City:		X-Coordinate:	<b>00298062</b>
Officer Notified:	<b>05:01</b> Hrs.	Miles From City:		Y-Coordinate:	<b>04757819</b>
Officer Arrived:	<b>05:15</b> Hrs.	Road, Street, HWay:		Location Literal:	<b>6658 HWY 10 BLVD</b>
Scene Investigated:	<b>Yes</b>	Definable Location:		Description:	
		Milepost Number:

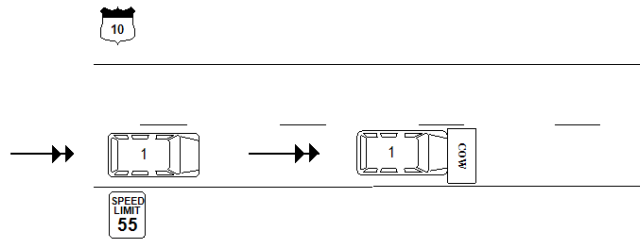
Diagram

Unit 1 was eastbound on Hwy 10 Blvd and struck a 550lb steer that was on the roadway.
