INFORMATION FROM THE INVESTIGATING OFFICERS REPORT OF MOTOR VEHICLE ACCIDENT

Case Number: 18-002345	Report to All Drivers: Yes	At Intersection with:
Date of Acc: 04/22/18	Legal Intervention: No	Div HWay Trvl Dir:
Time of Acc: 09:30 Hrs.	Private Property: No	Distance 1:
Name of Agency: O'Brien County Sheriff's Off	County: O'Brien - 71	Direction 1:
Officer: VANDERVEEN STEVEN	Acc Loc City:	Distance 2:
Badge #: 71-9	Acc Dir From City:	Direction 2:
Report Date: 04/22/2018	Closest City:	X-Coordinate: 00297449
Officer Notified: 09:42 Hrs.	Miles From City:	Y-Coordinate: 04769546
Officer Arrived: 09:48 Hrs.	Road, Street, HWay:	Location Literal: M012/VINE AVE
Scene Investigated: Yes	Definable Location:	Description:
	Milepost Number:

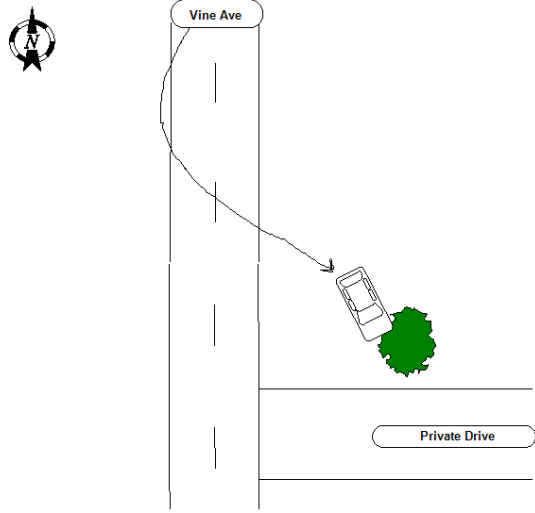
Diagram

Vehicle #1 was southbound on Vine Avenue (M-12). It appears the driver dropped off the right shoulder of the road. The driver then over corrected the vehicle and went into the east ditch. Vehicle #1 then impacted a tree.
