INFORMATION FROM THE INVESTIGATING OFFICERS REPORT OF MOTOR VEHICLE ACCIDENT

Case Number:	17-007112	Report to All Drivers:	Yes	At Intersection with:	
Date of Acc:	10/25/17	Legal Intervention:	No	Div HWay Trvl Dir:	
Time of Acc:	16:17 Hrs.	Private Property:	No	Distance 1:	
Name of Agency:	O'Brien County Sheriff's Off	County:	O'Brien - 71	Direction 1:	
Officer:	ROHRBAUGH TIMOTHY	Acc Loc City:		Distance 2:	
Badge #:	71-5	Acc Dir From City:		Direction 2:	
Report Date:	10/25/2017	Closest City:		X-Coordinate:	00291512
Officer Notified:	16:20 Hrs.	Miles From City:		Y-Coordinate:	04784595
Officer Arrived:	16:28 Hrs.	Road, Street, HWay:		Location Literal:	US 18/320TH ST
Scene Investigated:	Yes	Definable Location:		Description:	
		Milepost Number:

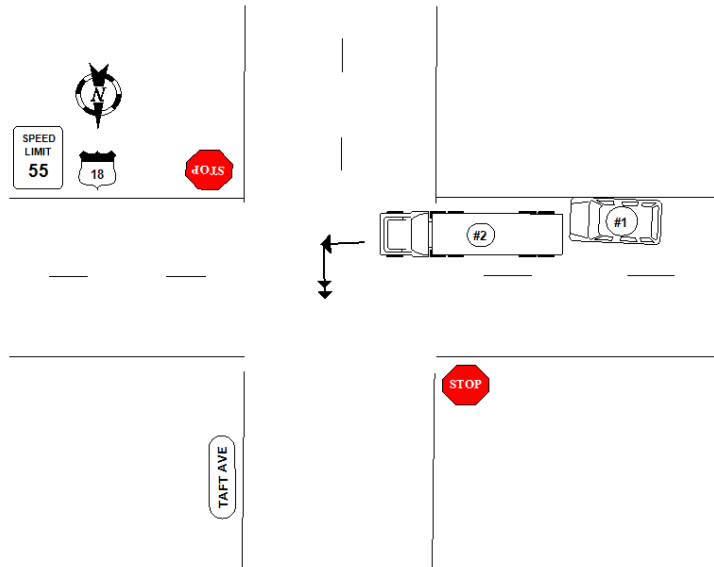
Diagram

BOTH VEHICLES WERE TRAVELING EAST ON HIGHWAY 18. VEHICLE #2 WAS GOING TO TURN LEFT ONTO TAFT AVE. VEHICLE #1 WAS LOOKING AT THE FARM PLACE TO HIS LEFT. WHEN THE DRIVER OF VEHICLE #1 TURNED HIS ATTENTION BACK TO THE ROAD, HE DISCOVERED THAT VEHICLE #2 WAS MAKING A LEFT TURN. AT THAT POINT IT WAS TOO LATE AND VEHICLE #1 RAN INTO VEHICLE #2.
