INFORMATION FROM THE INVESTIGATING OFFICERS REPORT OF MOTOR VEHICLE ACCIDENT

Case Number:	18-000121	Report to All Drivers:	Yes	At Intersection with:	
Date of Acc:	01/06/18	Legal Intervention:	No	Div HWay Trvl Dir:	
Time of Acc:	10:30 Hrs.	Private Property:	No	Distance 1:	
Name of Agency:	O'Brien County Sheriff's Off	County:	O'Brien - 71	Direction 1:	
Officer:	STEVENS BRAD	Acc Loc City:		Distance 2:	
Badge #:	71-10	Acc Dir From City:		Direction 2:	
Report Date:	01/07/2018	Closest City:		X-Coordinate:	00294236
Officer Notified:	19:00 Hrs.	Miles From City:		Y-Coordinate:	04764578
Officer Arrived:	19:51 Hrs.	Road, Street, HWay:		Location Literal:	TYLER AVE
Scene Investigated:	Yes	Definable Location:		Description:	
		Milepost Number:

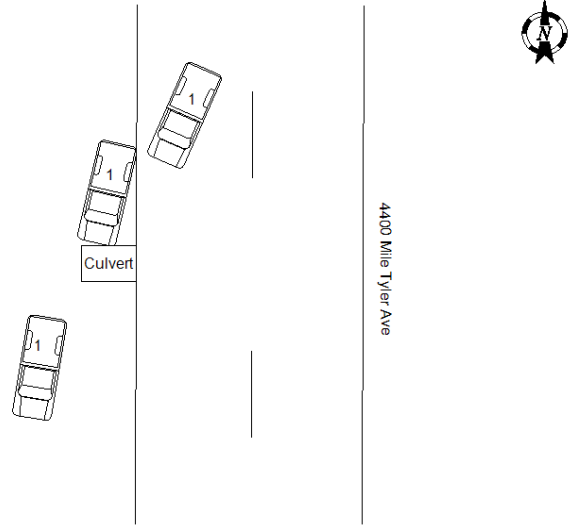
Unit 1 was southbound in the 4400 mile of Tyler Avenue. Unit 1 lost control and entered the west ditch, striking a culvert. Unit 1 came to west in the adjacent field.
