**INFORMATION FROM THE INVESTIGATING OFFICERS REPORT OF MOTOR VEHICLE ACCIDENT**

Case Number:	<b>S20-004977</b>	Report to All Drivers:		At Intersection with:	
Date of Acc:	<b>07/30/20</b>	Legal Intervention:	<b>NO</b>	Div HWay Trvl Dir:	
Time of Acc:	<b>03:53</b> Hrs.	Private Property:	<b>NO</b>	Distance 1:	
Name of Agency:	<b>O'BRIEN COUNTY SHERIFF'S OFF</b>	County:	<b>O'BRIEN - 71</b>	Direction 1:	
Officer:	<b>DEPUTY KEVEN VANMEETEREN</b>	Acc Loc City:		Distance 2:	
Badge #:	<b>71-7</b>	Acc Dir From City:		Direction 2:	
Report Date:	<b>07/30/2020</b>	Closest City:		X-Coordinate:	<b>00292303</b>
Officer Notified:	<b>03:53</b> Hrs.	Miles From City:		Y-Coordinate:	<b>04755582</b>
Officer Arrived:	<b>04:00</b> Hrs.	Road, Street, HWay:		Location Literal Description:	<b>B062/500TH ST</b>
Scene Investigated:	<b>YES</b>	Definable Location:			
		Milepost Number:

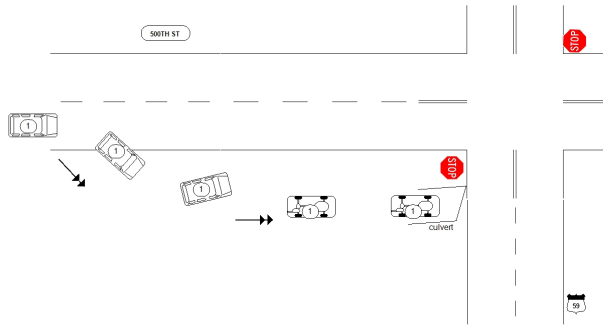
# Diagram

UNIT 1 EASTBOUND ON 500TH ST. DRIVER LOST CONTROL, ENTERED SOUTH DITCH AND ROLLED ONTO IT'S TOP AND STRUCK A CULVERT OPENING.
