**INFORMATION FROM THE INVESTIGATING OFFICERS REPORT OF MOTOR VEHICLE ACCIDENT**

Case Number: **20007120**  
 Date of Acc: **10/17/20**  
 Time of Acc: **11:32** Hrs.  
 Name of Agency: **O'BRIEN COUNTY SHERIFF'S OFF**  
 Officer: **DEPUTY JETT KORVER**  
 Badge #: **71-8**  
 Report Date: **10/17/2020**  
 Officer Notified: **11:32** Hrs.  
 Officer Arrived: **11:58** Hrs.  
 Scene Investigated: **YES**

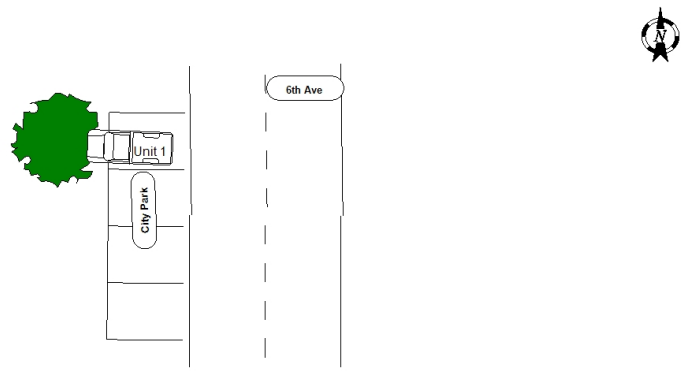
**Diagram**

Unit one was in the 500 block of 6th Ave in Sheldon when the driver turned into the city park, parking area to turn around. The driver of unit one stepped on the accelerator

instead of the break and struck a tree causing front end damage to the vehicle.
