INFORMATION FROM THE INVESTIGATING OFFICERS REPORT OF MOTOR VEHICLE ACCIDENT

Law Enforcement
 Case Number: **22-005274**
 Date of Acc: **07/24/22**
 Time of Acc: **21:40** Hrs.
 Name of Agency: **O'BRIEN COUNTY SHERIFF'S OFF**
 Officer: **DEPUTY TIMOTHY ROHRBAUGH**
 Badge #: **71-5**
 Report Date: **07/25/2022**
 Officer Notified: **21:40** Hrs.
 Officer Arrived: **21:54** Hrs.

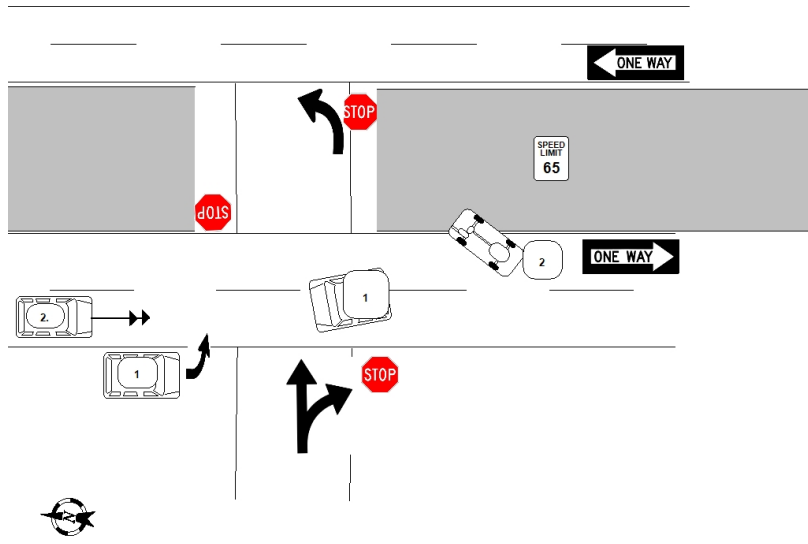
Diagram

VEHICLE ONE WAS TRAVELING NORTH IN THE SOUTH BOUND LANE. SEVERAL PEOPLE STOPPED AND SIGNALLED VEHICLE ONE THAT IT WAS GOING THE WRONG WAY. VEHICLE ONE DID A U-TURN AND NOW WAS FACING SOUTH IN THE SOUTH LANES, PARKED ON THE RIGHT SHOULDER OF THE ROAD. VEHICLE ONE TURNED LEFT FROM THE RIGHT SHOULDER AND ATTEMPTED TO CROSS BOTH SOUTH BOUND LANES OF TRAFFIC. VEHICLE TWO WAS TRAVELING SOUTH AND VEHICLE ONE TURNED RIGHT IN FRONT OF HER. VEHICLE TWO ROLLED APPROXIMATELY SIX TIMES AND CAME TO REST ON IT ROOF. VEHICLE ONE WAS RECENTLY PURCHASED AND STILL HAD THE PAPER DEALER PLATE.
