INFORMATION FROM THE INVESTIGATING OFFICERS REPORT OF MOTOR VEHICLE ACCIDENT

Law Enforcement
 Case Number: **23-001018**
 Date of Acc: **02/16/23**
 Time of Acc: **10:00** Hrs.
 Name of Agency: **O'BRIEN COUNTY SHERIFF'S OFF**
 Officer: **DEPUTY BRAD STEVENS**
 Badge #: **71-10**
 Report Date: **02/21/2023**
 Officer Notified: **10:45** Hrs.
 Officer Arrived: **11:07** Hrs.

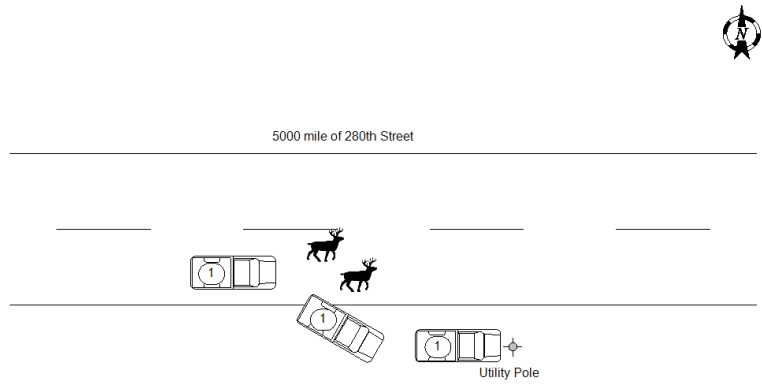
Diagram

Unit 1 was eastbound in the 5000 mile of 280th Street. Driver states (2) deer ran onto the roadway. Unit 1 swerved and left the roadway, entered the south ditch before striking a utility pole and coming to rest.
