**INFORMATION FROM THE INVESTIGATING OFFICERS REPORT OF MOTOR VEHICLE ACCIDENT**

Law Enforcement  
 Case Number: **23-005145**  
 Date of Acc: **08/01/23**  
 Time of Acc: **13:22** Hrs.  
 Name of Agency: **O'BRIEN COUNTY SHERIFF'S OFF**  
 Officer: **DEPUTY JETT KORVER**  
 Badge #: **71-8**  
 Report Date: **08/01/2023**  
 Officer Notified: **13:22** Hrs.  
 Officer Arrived: **13:24** Hrs.

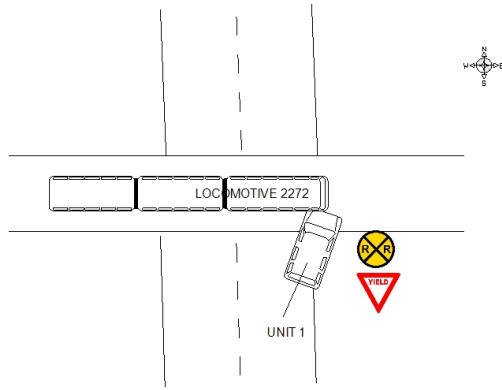
Diagram

A Canadian Pacific train was eastbound with the locomotive, being operated by Engineer John M. Shannon, upon approaching Redwing Ave the crew sounded the train's horn, all lights on the front of the locomotive were on and functioning properly. The driver of Unit 1 was northbound on Redwing Ave and stated she thought the train was stopped but upon hearing the train's horn tried to stop. The driver of unit one locked up her brakes, leaving skid marks, and pulled to the right shoulder of the road. Unit 1 hit the side of the locomotive under the area where the engineer sits. Unit 1 was damaged on the front drivers side. The locomotive appears only to have scuff marks from the impact. No other damage was observed. Train conductor Brian Halsey was also in the locomotive and witnessed the accident.
