**INFORMATION FROM THE INVESTIGATING OFFICERS REPORT OF MOTOR VEHICLE ACCIDENT**

Law Enforcement  
 Case Number: **24-000550**  
 Date of Acc: **01/31/24**  
 Time of Acc: **07:10** Hrs.  
 Name of Agency: **O'BRIEN COUNTY SHERIFF'S OFF**  
 Officer: **LIEUTENANT STEVEN VANDERVEEN**  
 Badge #: **71-3**  
 Report Date: **01/31/2024**  
 Officer Notified: **07:16** Hrs.  
 Officer Arrived: **07:25** Hrs.

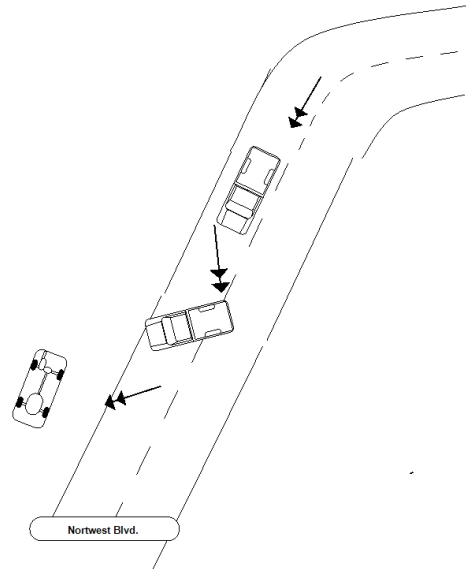
Vehicle #1 was southbound on Northwest Blvd. The road surface was frosty and slick. The driver lost traction, spun around and entered the west ditch. The vehicle flipped over onto its roof.
